FACILITY STATUS CHANGE FORM

Date Submitted: August 8, 2013 Originator: Chris Strand Phone: 554-2720	Area: 300 Area Facility ID: 331G Action Memorandum: Hanford General Decommissioning	Control #: D4-300-087
---	---	---------------------------------

331G Building History

300 D4 331-G, H GPERS Radiological Survey Beta Track Map

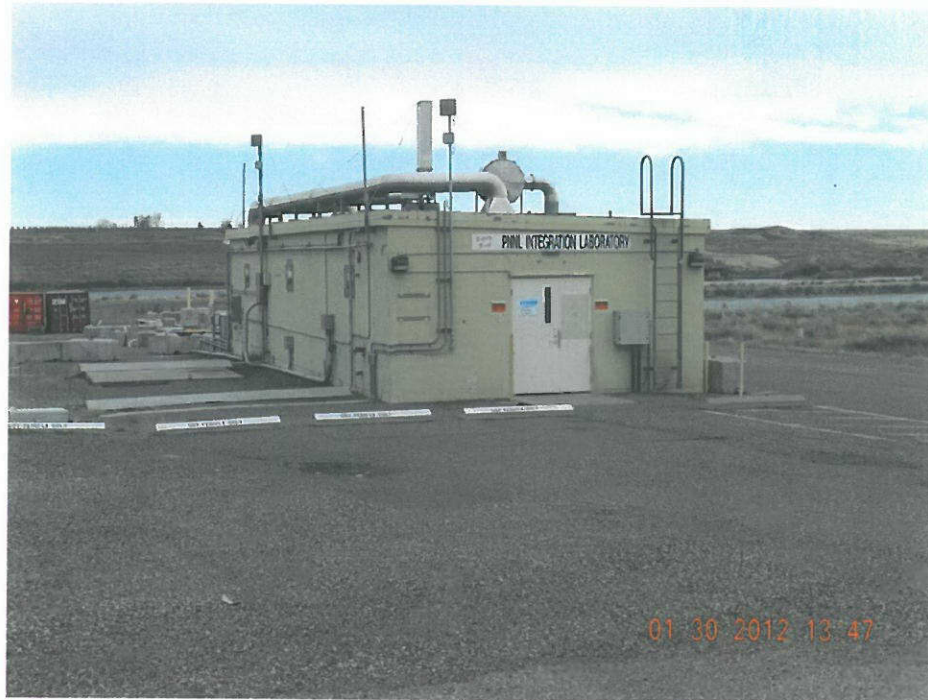
Photograph 1: 331G, looking east on January 30, 2012.

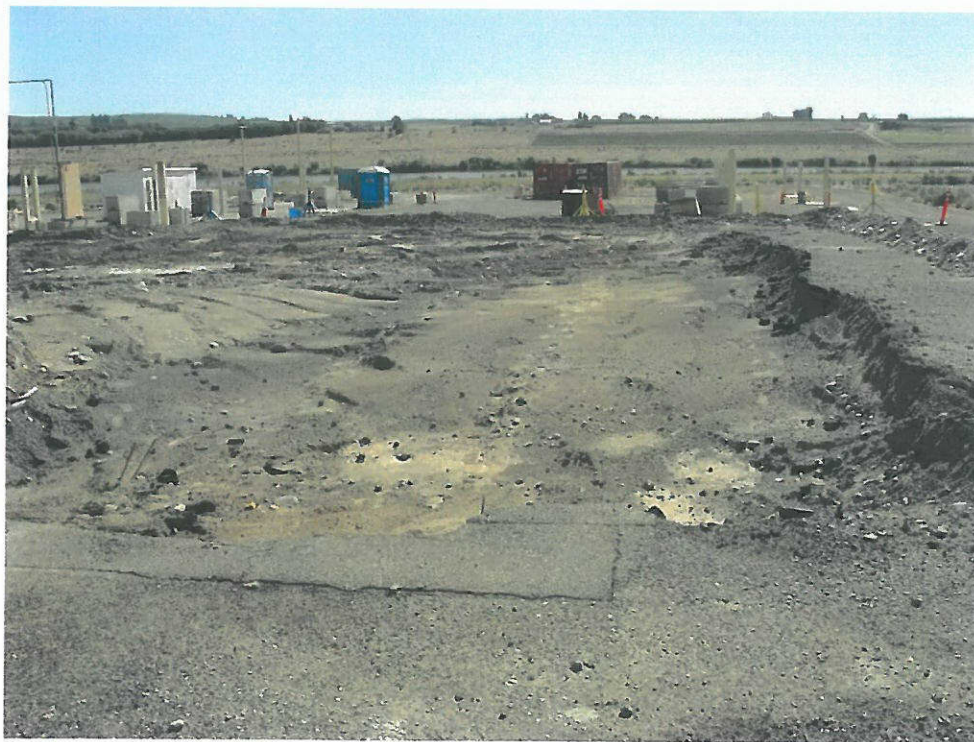
Photograph 2: 331G excavation following below-grade demolition, looking east on July 22, 2013.

No anomalies were discovered during the below-grade removal of 331G. Unusual light colored soil was observed in the excavation to the north, between 331H and 331G Buildings. Project Analytical Lead and Environmental staff evaluated the site and concluded the material was clay. No other soil staining within the excavation was observed and GPERS surveys identified no radiological contamination. The excavation was backfilled with clean fill material.

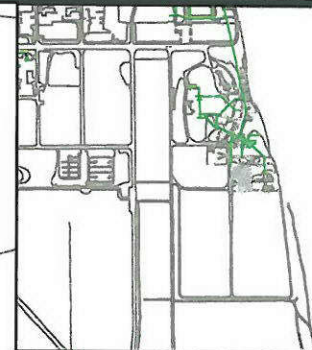
Bkg Location
1250 m NW
351 cpm

Coverage File: D4_199'
Number of Data Pnts: 244
Type of Survey: beta
Max GCPM: 631
Avg Bkg CPM: 351
Survey Date: 7/19/2013
Area Surveyed: 1600 m²
Project File: ESRFRM130057B
Pdf File: ESRFRM130057BC

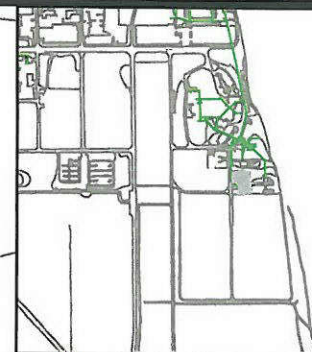
300 D4 331-G, H GPERS Radiological Survey Gamma Track Map

Bkg Location
1250 m NW
1154 cpm

Coverage File: D4_199
Number of Data Pnts: 3378
Type of Survey: gamma
Max GCPM: 1622
Avg Bkg CPM: 1154
Survey Date: 7/19/2013
Area Surveyed: 1600 m²
Project File: ESRFRM130057G
Pdf File: ESRFRM130057GC

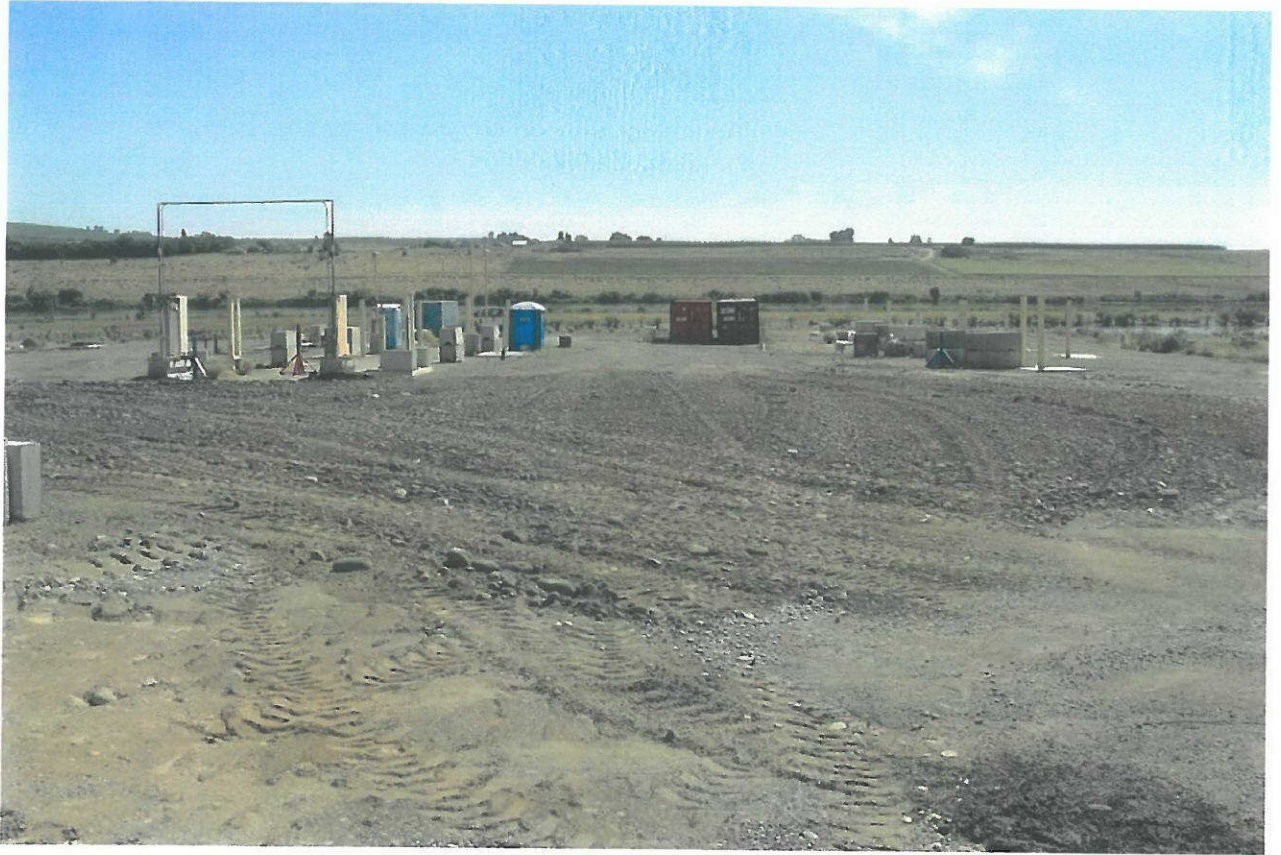
Photograph 3: 331G following backfill, looking east on August 7, 2013

The excavation was backfilled with clean material following GPERS surveys. No radiological or Industrial Hygiene postings remain.
